**Embercoat Primer**

### TEST REPORT RADIANT HEAT EXPOSURE BAL 29 INDICATIVE TESTING

IGNL-100019-23R I01R00

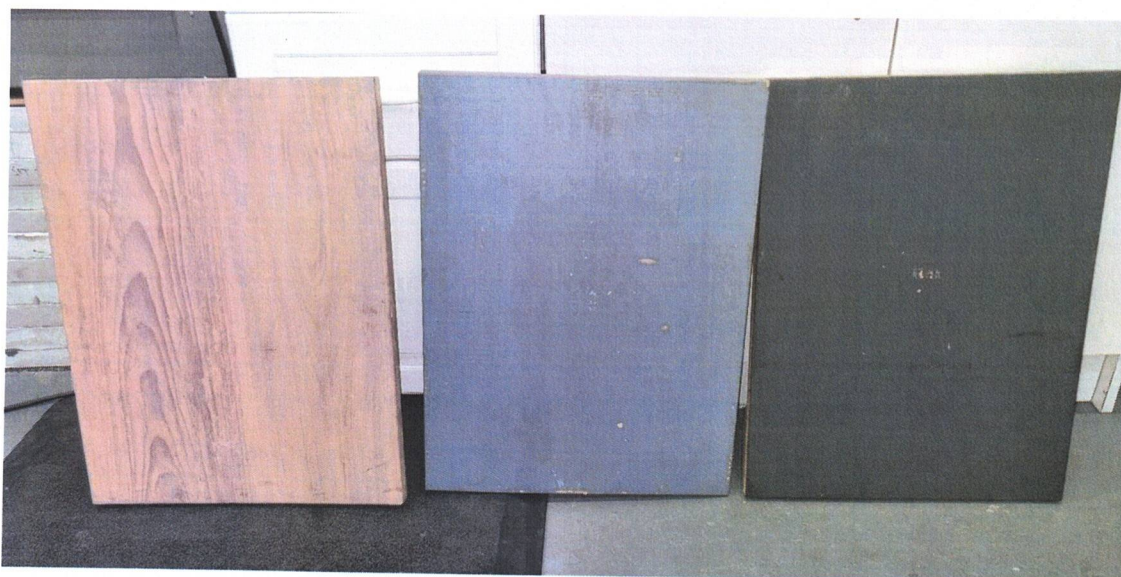
**FIGURE 1:**

The specimens before the test are shown below:

TEST SPECIMEN IMAGE

- Specimen height (mm): 600 mm (Sp1), 600 mm (Sp2), 600 mm (Sp3)
- Specimen width (mm): 450 mm (Sp1), 450 mm (Sp2), 450 mm (Sp3)
- Specimen thickness (mm): 26.91 mm (Sp1), 26.44 mm (Sp2), 26.93 mm (Sp3)
- Specimen colour: Clear (Sp1), Pale grey (Sp2), Dark grey (Sp3)
